Navajo Abandoned Uranium Mine

Site Screen Report

Adolf Maloney No. 2 AUM Site

January 2011

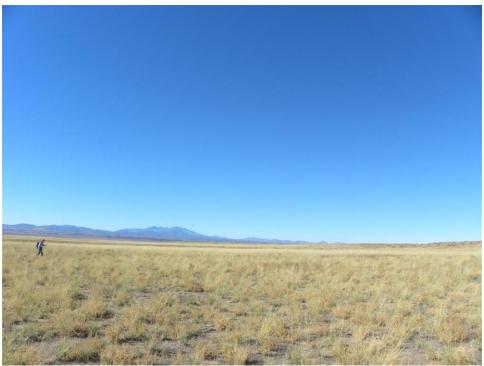
Photo 1. Adolf Maloney mine site

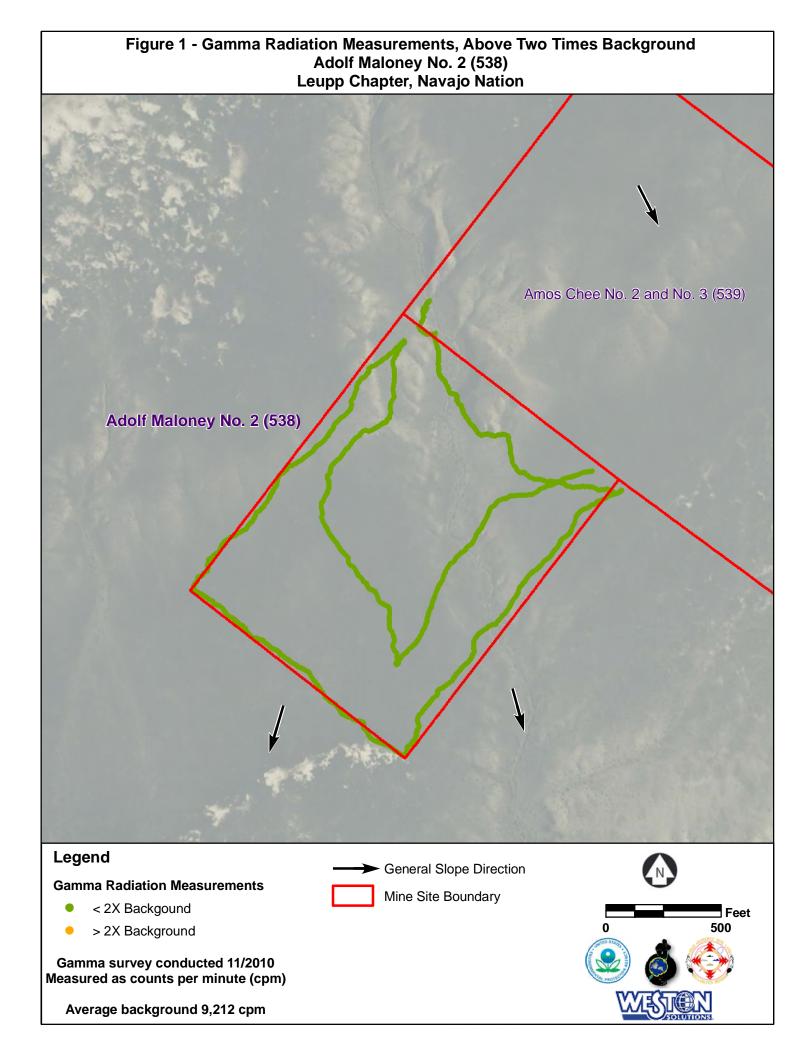
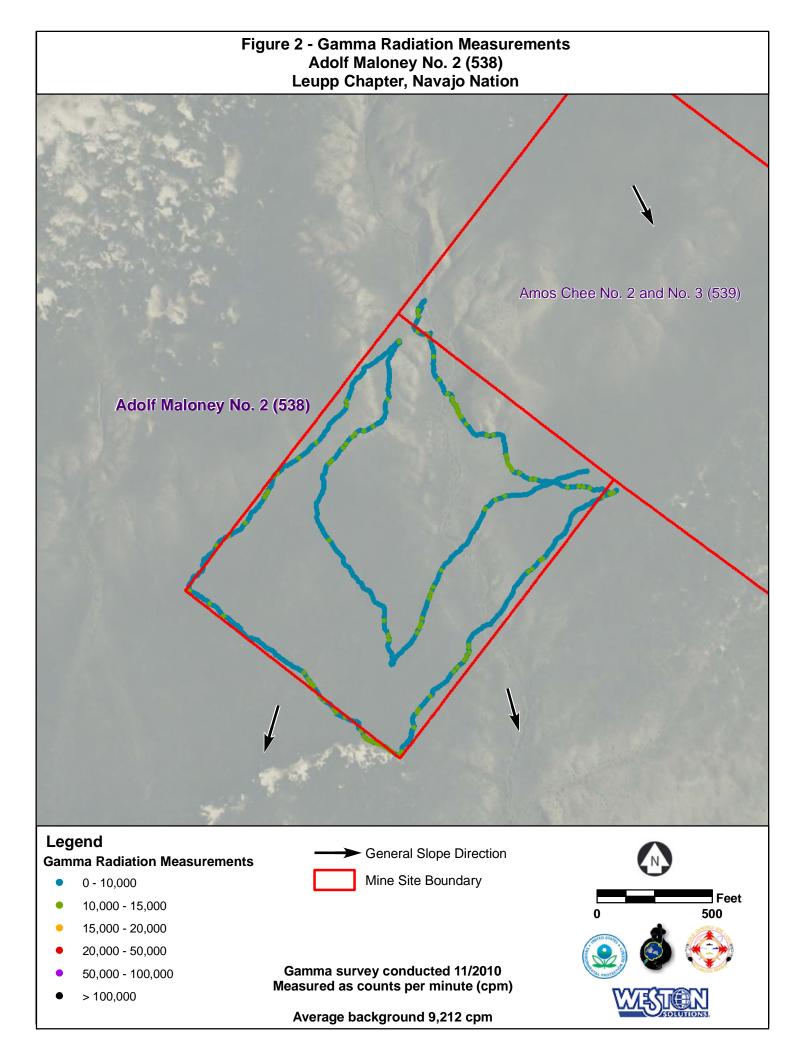
A total of 3,212 gamma radiation measurements were collected from the mine site, ranging from 6,728 cpm to 11,501 cpm. The measurements are represented in Figures 1 and 2.
